Manhole Inspection Summary

Manhole # S45MM_038MH

Insp Date: **2/24/10 1:10 PM**

Location Address: **1916 N. Wolfe St.**

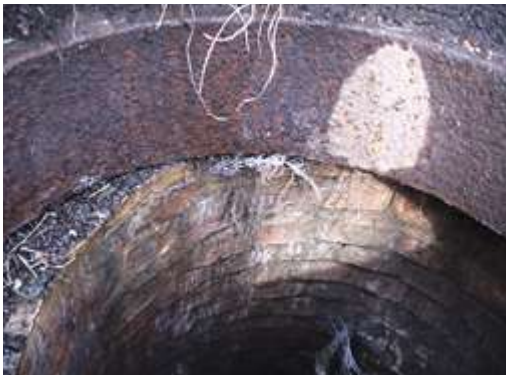
Defect 4

offset

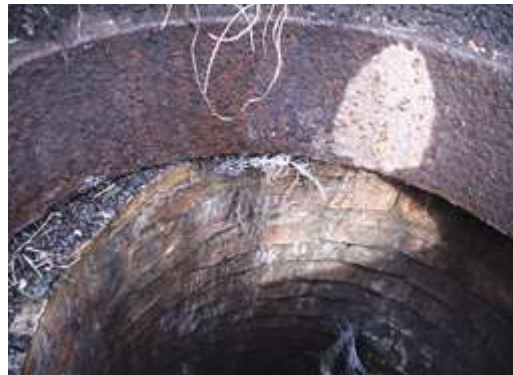
Defect 3

Offset: **4** (in.)

offset

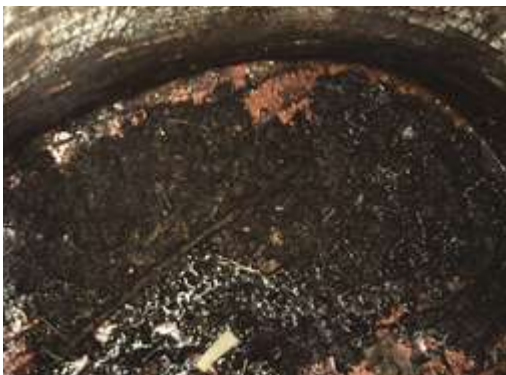
Defect 2

debris

Deposits: ☐ None ☐ Mud ☐ Sludge ☒ **Debris** ☐ Grease

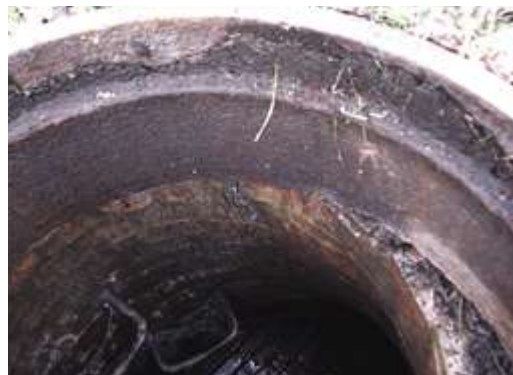
Defect 1

☒ **Leaks**

frame leaks

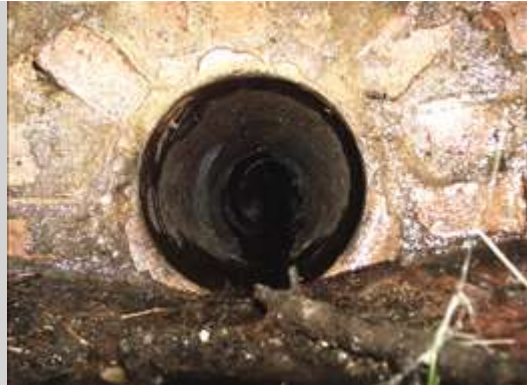
12 O'Clock Outflow

8 in. Circular Gravity Sewer
Pipe Out @ 12 O'Clock

Silt Depth: **1** (in.) Deposits Extent: **Light**
